**Flood Control Project Maintenance
Levee Inspections**

Fall 2016 Levee Maintenance Deficiency Summary Report

Reclamation District No. 1500 Sutter Basin

Fall 2016 Levee Inspection Results

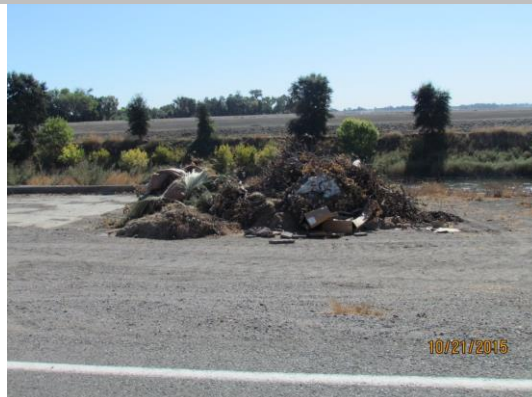
Photo 1 of 1 : FA_2016_RD1500_189_116_20160913_00061.jpg

LM Start	11.99	Rating **	M	Issue No.	116
LM End	11.99	Issue Type +	En	Location *	WS
Category	Earthen Levee			GPS Latitude/Longitude	
				Start	End
Item	Encroachments			38.870840 °	38.870840 °
				-121.752594 °	-121.752594 °
DWR ID	DWR_RD1500_01_f_2015_116				
Comment Code					
GA : Garbage					
Inspector Comment

View of the debris on the waterward side of the levee. Fall 2015.

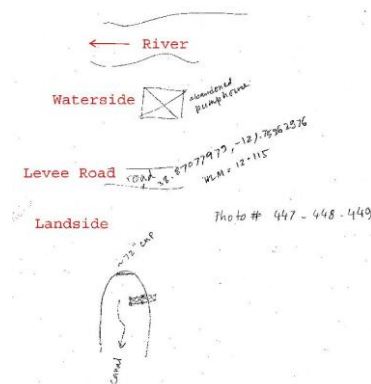
Photo 1 of 2 : UCIP_FA_2016_41744_51343.jpg

LM Start	12.00	Rating **	M	Issue No.	2590
LM End	12.00	Issue Type +	En	Location *	WS
Category	Supplemental			GPS Latitude/Longitude	
				Start	End
Item	DWR UCIP Field Study			38.870780 °	38.870780 °
				-121.752630 °	-121.752630 °
DWR ID					
Comment Code					
Inspector Comment					
FS_ID:41744					
DS_ID:20008					
EP_NO: N/A					
Repair Type: Non-Urgent					
Crossing Status: Indicator Found					
UCIP Comments: An abandoned pump house on waterside and a 72-inch corrugated metal pipe on landside. The pipe discharges into irrigation ditch (canal). Water was flowing during the field visit. Needs to verify from LMA whether this pipe is through the levee or not.					
FIELD_STRUCT_DESC: 1 of 2: Two 4 foot and 3.5 foot concrete culverts through levee, 17 feet below the crown, pump on WS.					
FS Date: 1/10/2014

Sketch of Utility Crossing @HLM 12.115

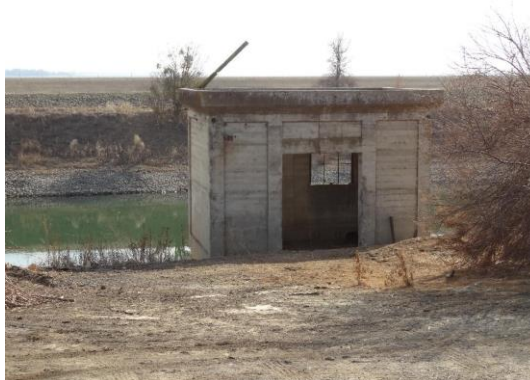
Photo 2 of 2 : UCIP_FA_2016_41744_51345.jpg

WS view: abandoned concrete pump house. No pump and pipe found.

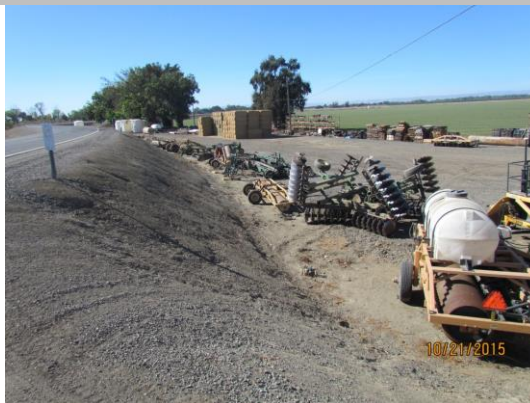
Photo 1 of 1 : FA_2016_RD1500_189_24_20160913_00020.jpg

LM Start	12.42	Rating **	M	Issue No.	24
LM End	12.53	Issue Type +	En	Location *	LS
Category	Earthen Levee			GPS Latitude/Longitude	
				Start	End
Item	Encroachments			38.868834 °	38.867492 °
				-121.760014 °	-121.760903 °
DWR ID	DWR_RD1500_01_s_2012_24				
Comment Code					
EQ : Equipment					
Inspector Comment

View of the equipment on the landward side of the levee looking upstream. Fall 2015.

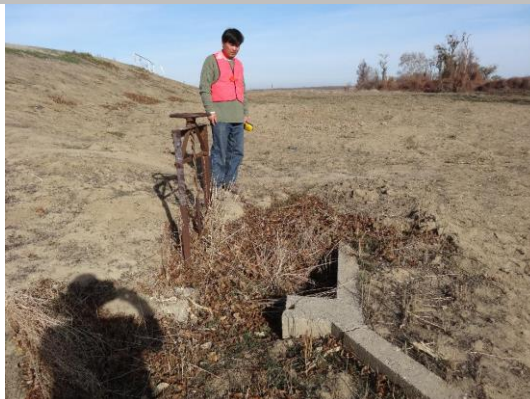
Photo 1 of 2 : UCIP_FA_2016_50197_52425.jpg

FS_ID:50197
DS_ID:20063
EP_NO: 10061
Repair Type: Non-Urgent
Crossing Status: Found
UCIP Comments: 08/29/2016 Same as last inspection. (K. Fazel - UCIP)01/10/2014 Needs proper abandonment. (P. Amatya - DWR)
FIELD_STRUCT_DESC: *ABANDONED* 18-inch corrugated metal drainage pipe through the levee, 15 feet below the crown. Slide gate in 4-foot by 4-foot concrete box at the waterside (WS) toe. Concrete box at the landside (LS) toe. Pipe crosses overflow area to the river.
(Automatic Board Order (ABO) issued as Permit No. 10061, 1974 - Matteoli). [Additional Reference(s): DWR Levee Log, 2005. USACE Sacramento O&M Manual 128, March 1960 (HLM 12.69)].
FS Date: 8/29/2016

WS view: slide gate (left) in concrete box at levee toe. Slide gate and the box mostly burried.

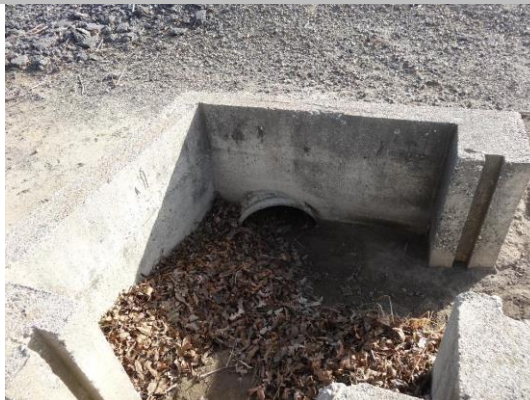
Photo 2 of 2 : UCIP_FA_2016_50197_52424.jpg

LS view: concrete intake box on levee toe.

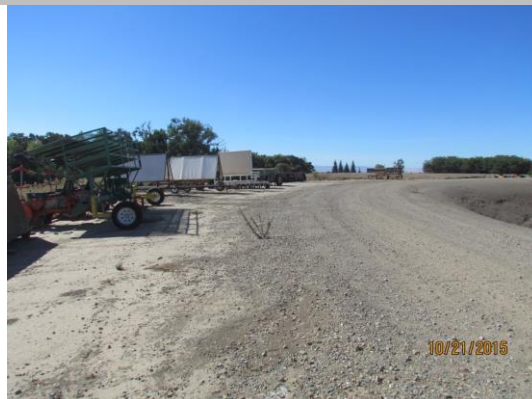
Photo 1 of 1 : FA_2016_RD1500_189_28_20160913_00023.jpg

LM Start	13.96	Rating **	M	Issue No.	28
LM End	13.96	Issue Type +	En	Location *	CR
Category	Earthen Levee			GPS Latitude/Longitude	
				Start	End
Item	Encroachments			38.857625 °	38.857625 °
				-121.782832 °	-121.782832 °
DWR ID	DWR_RD1500_01_s_2012_28				
Comment Code					
EQ : Equipment					
Inspector Comment					
Equipment are on the crown of the levee but does not obstruct access.

View of the equipment on the crown side of the levee looking upstream.
Fall 2015.

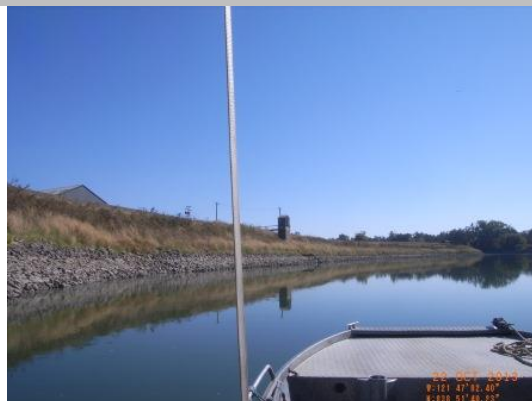
Photo 1 of 1 : FA_2016_RD1500_189_10_20160913_00011.jpg

LM Start	13.98	Rating **	M	Issue No.	10
LM End	14.26	Issue Type +	Ma	Location *	WS
Category	Supplemental			GPS Latitude/Longitude	
				Start	End
Item	2015 USACE Erosion Survey, DRAFT			38.857239 °	38.861899 °
				-121.783771 °	-121.784057 °
DWR ID	DWR_RD1500_01_s_2016_10				
Comment Code					
Inspector Comment					
1997 - Intermittent toe failure of the hand placed riprap; failure of toe materials. 2015: No observed changes. [2015 Site ID: SAC_99-0_L]

USACE 2013 Photo #1

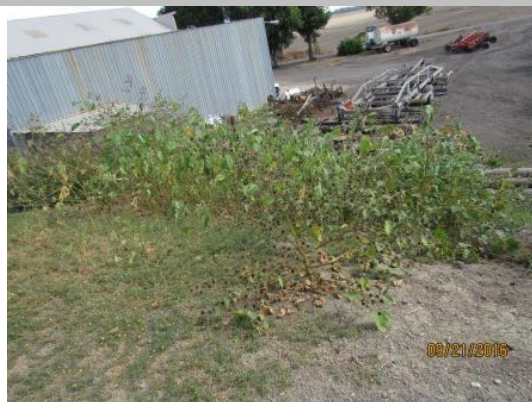
Photo 1 of 1 : FA_2016_RD1500_189_122_20160926_00265.jpg

LM Start	14.17	Rating **	M	Issue No.	122
LM End	14.17	Issue Type +	Ma	Location *	LS
Category	Earthen Levee			GPS Latitude/Longitude	
				Start	End
Item	Vegetation			38.860368 °	38.860368 °
				-121.783268 °	-121.783268 °
DWR ID	DWR_RD1500_01_f_2016_122				
Comment Code					
V2 : Remove the wild growth other than native grasses from the levee slopes.					
Inspector Comment

Vegetation on LS of the levee. Fall 2016.

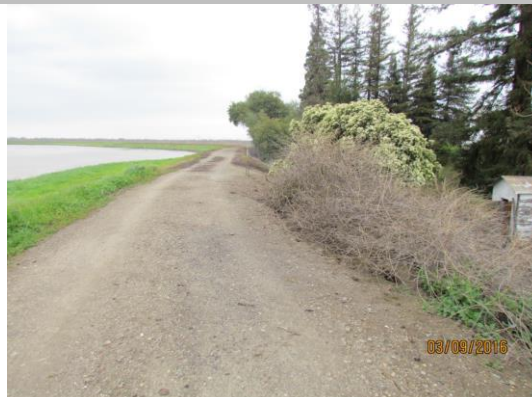
Photo 1 of 1 : FA_2016_RD1500_189_31_20160913_00025.jpg

LM Start	14.24	Rating **	M	Issue No.	31
LM End	14.24	Issue Type +	En	Location *	LS
Category	Earthen Levee			GPS Latitude/Longitude	
				Start	End
Item	Vegetation			38.861335 °	38.861335 °
				-121.783605 °	-121.783605 °
DWR ID	DWR_RD1500_01_s_2012_31				
Comment Code					
V6 : Landscaping					
Inspector Comment

View of the landscaping on the landward side of the levee looking upstream. Spring 2016.

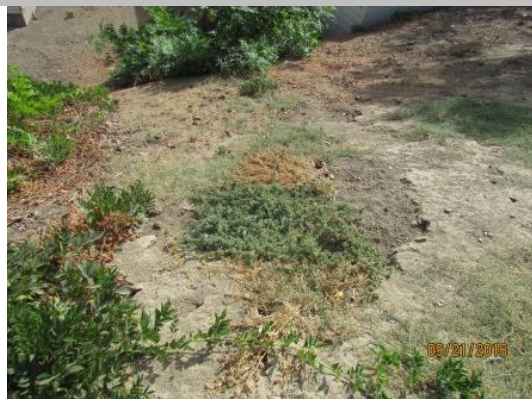
Photo 1 of 1 : FA_2016_RD1500_189_115_20160926_00263.jpg

LM Start	14.24	Rating **	M	Issue No.	115
LM End	14.24	Issue Type +	Ma	Location *	LS
Category	Earthen Levee			GPS Latitude/Longitude	
				Start	End
Item	Animal Control			38.861353 °	38.861353 °
				-121.783610 °	-121.783610 °
DWR ID	DWR_RD1500_01_s_2016_115				
Comment Code					
A1 : Exterminate rodents and backfill and compact or grout burrows.					
Inspector Comment					
Ground squirrel ran across the top of the levee to the landward side of the levee into the landscaping.

View of rodent burrows on LS slope of the levee. Fall 2016.

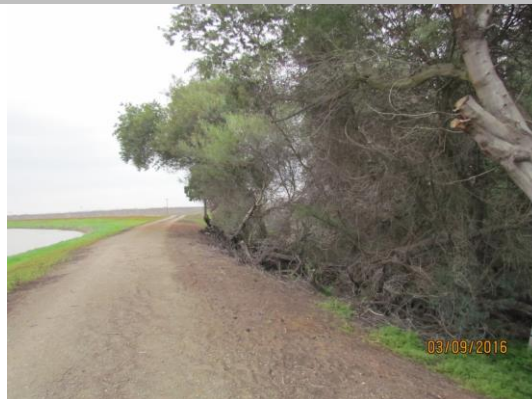
Photo 1 of 2 : FA_2016_RD1500_189_77_20160913_00048.jpg

LM Start	14.27	Rating **	U	Issue No.	77
LM End	14.27	Issue Type +	Ma	Location *	LS
Category	Earthen Levee			GPS Latitude/Longitude	
				Start	End
Item	Trim / Thin Trees			38.861793 °	38.861793 °
				-121.783703 °	-121.783703 °
DWR ID	DWR_RD1500_01_s_2012_77				
Comment Code					
T3 : Trim and thin trees to allow visibility of the ground and room to flood fight.					
Inspector Comment

View of the trees on the landward side of the levee looking upstream. Spring 2016.

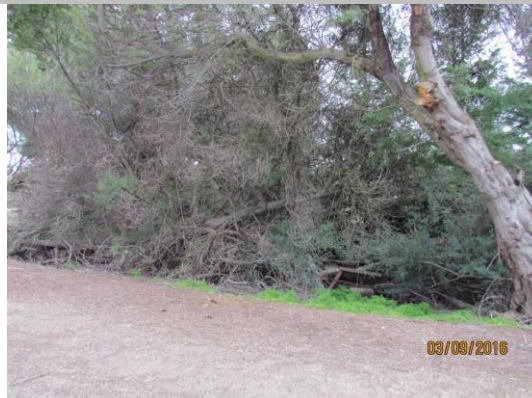
Photo 2 of 2 : FA_2016_RD1500_189_77_20160913_00049.jpg

Trees block visibility on the landward slope . Spring 2016.

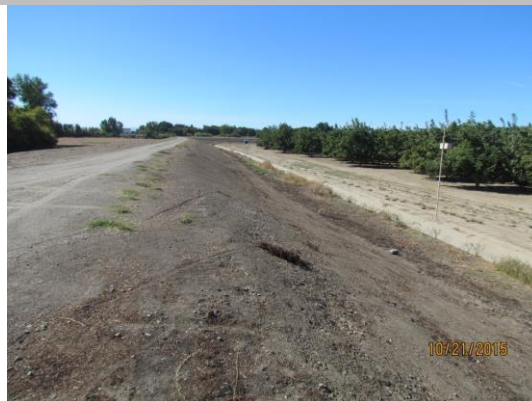
Photo 1 of 1 : FA_2016_RD1500_189_969_20160913_00083.jpg

LM Start	14.71	Rating **	M	Issue No.	969
LM End	15.76	Issue Type +	En	Location *	LS
Category	Earthen Levee			GPS Latitude/Longitude	
				Start	End
Item	Encroachments			38.865395 °	38.871827 °
				-121.789402 °	-121.804158 °
DWR ID	DWR_RD1500_01_s_2012_969				
Comment Code					
DT : Ditch					
Inspector Comment					
Ditch is at the levee toe.

View of the ditch on the landward side of the levee looking upstream. Fall 2015.

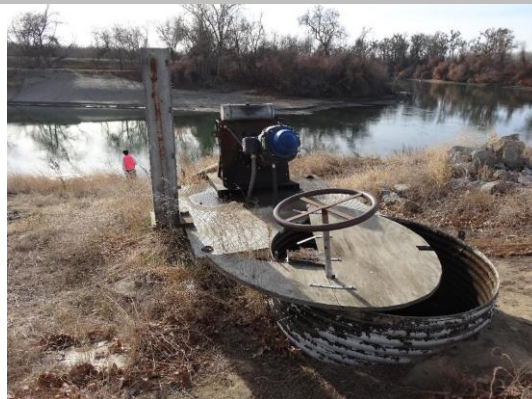
Photo 1 of 2 : UCIP_FA_2016_28486_52461.jpg

FS_ID:28486
DS_ID:20010
EP_NO: 10037
Repair Type: Non-Urgent
Crossing Status: Found
UCIP Comments: Water treatment plant on landside. Working during field visit. Not found- Flap Gate in 6.5 foot by 7.0 foot O.D. concrete distribution box at landward toe.
FIELD_STRUCT_DESC: 22-inch concrete encased steel irrigation pipe through levee, 17.5 feet below crown. 1.5 -inch conduit through levee, 6.0 feet below crown. Slant pump on river bank. Gate valve in CMP riser on waterside. A 6.5 foot by 7.0 foot O.D. concrete distribution box at landward toe. (ABO. No. 10037 - Clauss) O&M Manual Sac 128, March 1960.
FS Date: 1/10/2014

WS view: CMP riser with gate valve and slant pump on steel platform.

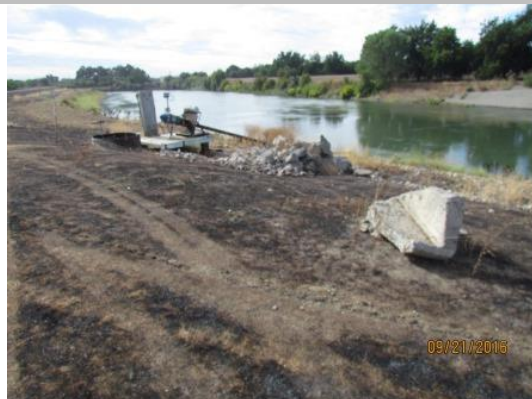
Photo 1 of 2 : FA_2016_RD1500_189_21_20160926_00262.jpg

LM Start	15.12	Rating **	M	Issue No.	21
LM End	15.12	Issue Type +	En	Location *	WS
Category	Earthen Levee			GPS Latitude/Longitude	
				Start	End
Item	Encroachments			38.866878 °	38.866878 °
				-121.794110 °	-121.794110 °
DWR ID	DWR_RD1500_01_s_2012_21				
Comment Code					
DE : Debris					
Inspector Comment					
A pile of rip rap and concrete needs to be removed.

Updated view of debris site on WS slope. Fall 2016.

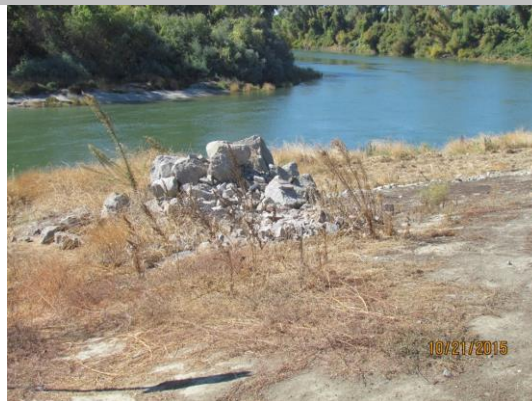
Photo 2 of 2 : FA_2016_RD1500_189_21_20160913_00018.jpg

View of the concrete debris on the waterward side of the levee. Fall 2015.

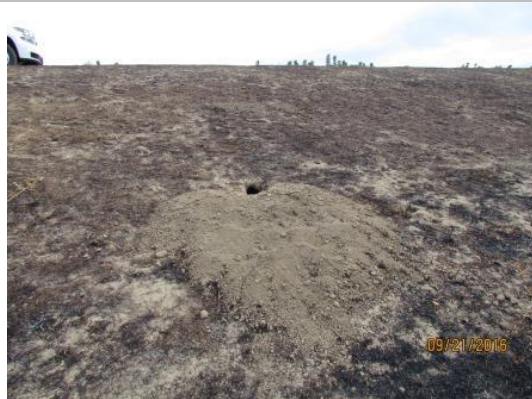
Photo 1 of 1 : FA_2016_RD1500_189_120_20160926_00261.jpg

LM Start	15.43	Rating **	M	Issue No.	120
LM End	15.43	Issue Type +	Ma	Location *	WS
Category	Earthen Levee			GPS Latitude/Longitude	
				Start	End
Item	Animal Control			38.869466 °	38.869466 °
				-121.798952 °	-121.798952 °
DWR ID	DWR_RD1500_01_f_2016_120				
Comment Code					
A3 : No rodents visible, but rodent burrows visible; need to backfill and compact or grout burrows.					
Inspector Comment

View of rodent burrow on waterward side of the levee. Fall 2016.

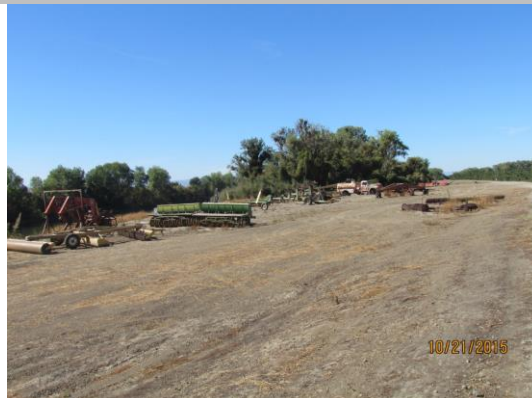
Photo 1 of 1 : FA_2016_RD1500_189_32_20160913_00026.jpg

LM Start	15.76	Rating **	M	Issue No.	32
LM End	15.76	Issue Type +	En	Location *	WS
Category	Earthen Levee			GPS Latitude/Longitude	
				Start	End
Item	Encroachments			38.871828 °	38.871828 °
				-121.804158 °	-121.804158 °
DWR ID	DWR_RD1500_01_s_2012_32				
Comment Code					
EQ : Equipment					
Inspector Comment

View of the equipment on the waterward side of the levee looking upstream. Fall 2015.

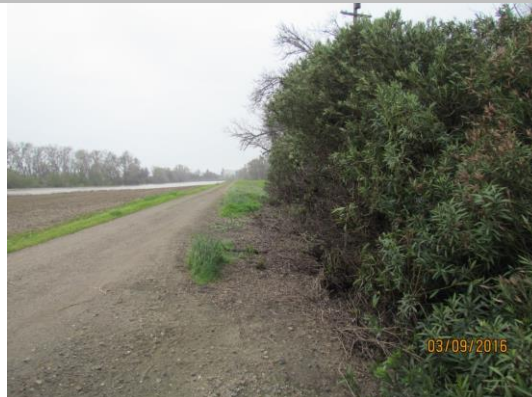
Photo 1 of 1 : FA_2016_RD1500_189_33_20160913_00027.jpg

LM Start	16.30	Rating **	M	Issue No.	33
LM End	16.30	Issue Type +	En	Location *	LS
Category	Earthen Levee			GPS Latitude/Longitude	
				Start	End
Item	Vegetation			38.875785 °	38.875785 °
				-121.812330 °	-121.812330 °
DWR ID	DWR_RD1500_01_s_2012_33				
Comment Code					
V6 : Landscaping					
Inspector Comment

View of the shrubs on the landward side of the levee looking upstream. Spring 2016.

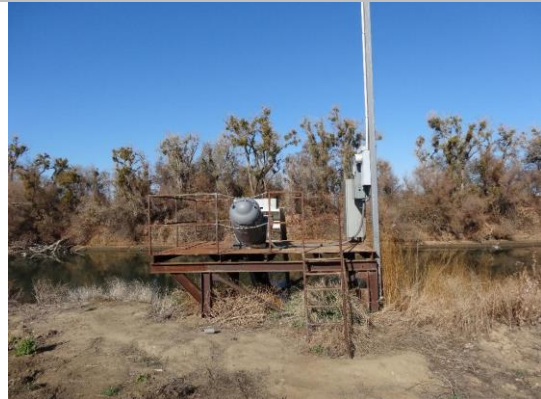
Photo 1 of 2 : UCIP_FA_2016_28490_52485.jpg

LM Start	17.27	Rating **	M	Issue No.	2573
LM End	17.27	Issue Type +	En	Location *	LS
Category	Supplemental			GPS Latitude/Longitude	
				Start	End
Item	DWR UCIP Field Study			38.887377 °	38.887377 °
				-121.808219 °	-121.808219 °
DWR ID					
Comment Code					
Inspector Comment					
FS_ID:28490 DS_ID:20066 EP_NO: 1739 Repair Type: Non-Urgent Crossing Status: Found UCIP Comments: Most of the pipe exposed on levee slope.Pipe leakage repaired recently.Siphon breaker requires protection. FIELD_STRUCT_DESC: 20-inch welded steel irrigation pipe through levee, 5.5 feet below crown. Slant pump mounted on steel structure on waterside. Siphon breaker on landward slope. Discharges into concrete distribution box at landward toe. (App. No. 1739 - Clauss) (RM 102.50) O&M Manual Sac 128, March 1960 FS Date: 1/14/2014

WS view: slant pump on steel platform on levee berm.

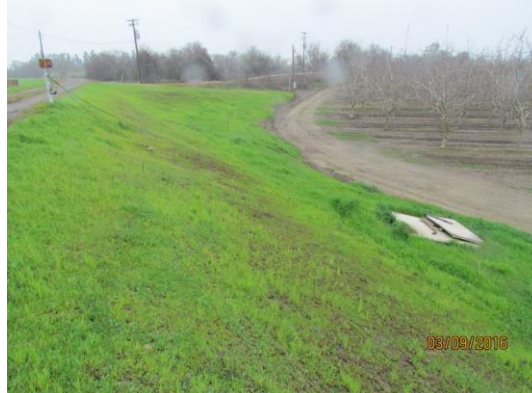
Photo 1 of 1 : FA_2016_RD1500_189_163_20160913_00075.jpg

LM Start	17.28	Rating **	M	Issue No.	163
LM End	17.28	Issue Type +	En	Location *	LS
Category	Earthen Levee			GPS Latitude/Longitude	
				Start	End
Item	Encroachments			38.887507 °	38.887507 °
				-121.808055 °	-121.808055 °
DWR ID	DWR_RD1500_01_s_2016_163				
Comment Code					
DE : Debris					
Inspector Comment

View of the debris at the toe of the levee on the landward side looking upstream. Spring 2016.

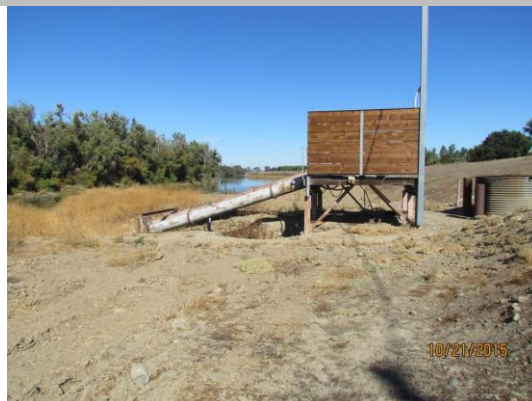
Photo 1 of 3 : FA_2016_RD1500_189_121_20160913_00064.jpg

LM Start	17.34	Rating **	M	Issue No.	121
LM End	17.34	Issue Type +	En	Location *	WS
Category	Earthen Levee			GPS Latitude/Longitude	
				Start	End
Item	Encroachments			38.888137 °	38.888137 °
				-121.807273 °	-121.807273 °
DWR ID	DWR_RD1500_01_f_2015_121				
Comment Code					
PI : Pipe					
Inspector Comment					
Pipe is causing the erosion on the berm of the levee.

Perspective view of the pump on the waterward side of the levee looking upstream. Fall 2015.

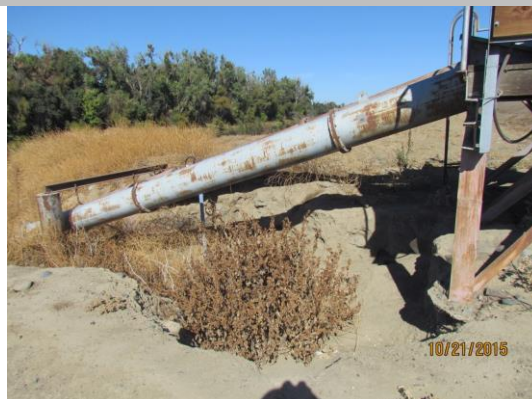
Photo 2 of 3 : FA_2016_RD1500_189_121_20160913_00065.jpg

LM Start	17.34	Rating **	M	Issue No.	121 (cont)	
LM End	17.34	Issue Type +	En	Location *	WS	
Category	Earthen Levee			GPS Latitude/Longitude		
				Start		End
Item	Encroachments			38.888137 °		38.888137 °
				-121.807273 °		-121.807273 °
DWR ID	DWR_RD1500_01_f_2015_121					
Comment Code						
PI : Pipe						
Inspector Comment						
Pipe is causing the erosion on the berm of the levee.

There is erosion underneath the pipe on the waterward berm area. Fall 2015.

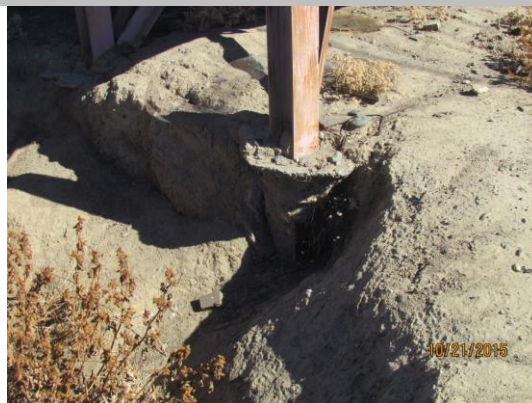
Photo 3 of 3 : FA_2016_RD1500_189_121_20160913_00066.jpg

The concrete for the base stand has been exposed due to erosion.

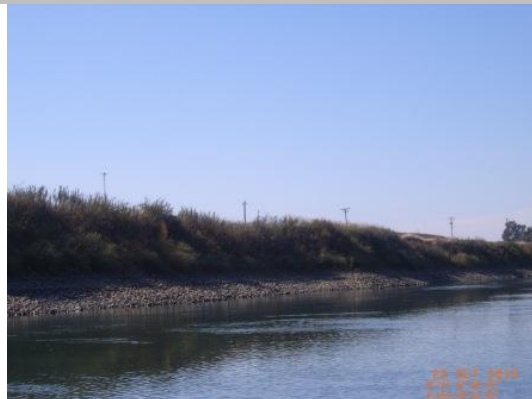
Photo 1 of 1 : FA_2016_RD1500_189_13_20160913_00013.jpg

LM Start	18.38	Rating **	M	Issue No.	13
LM End	19.06	Issue Type +	Ma	Location *	WS
Category	Supplemental			GPS Latitude/Longitude	
				Start	End
Item	2015 USACE Erosion Survey, DRAFT			38.901337 °	38.902721 °
				-121.801175 °	-121.790677 °
DWR ID	DWR_RD1500_01_s_2016_13				
Comment Code					
Inspector Comment					
1997 - Pocket failures of cobble revetment toe; scallops of rock loss along the bank; irregular bankline developing. 2001 - Small scallops in the toe of the berm. 2005 - Still multiple erosion pockets in the toe. 2006 - Two new small slumps. 2011 - Old cobble continue to fail causing minor slumping. 2012 - Portions of site appears to be stabilizing. 2015: No observed changes. [2015 Site ID: SAC_104-0_L]

USACE 2013 Photo #1

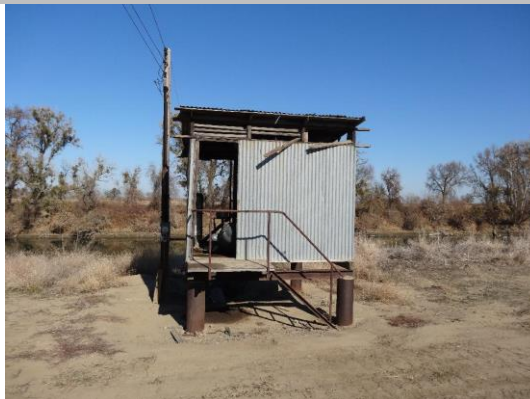
Photo 1 of 2 : UCIP_FA_2016_28505_52517.jpg

LM Start	18.40	Rating **	M	Issue No.	2574
LM End	18.40	Issue Type +	En	Location *	LS
Category	Supplemental			GPS Latitude/Longitude	
				Start	End
Item	DWR UCIP Field Study			38.900885 °	38.900885 °
				-121.800999 °	-121.800999 °
DWR ID					
Comment Code					
Inspector Comment					
FS_ID:28505 DS_ID:20068 EP_NO: 2425 Repair Type: Non-Urgent Crossing Status: Found UCIP Comments: Concrete pad on both sides of the levee shoulders.Oil leaks from pump set. FIELD_STRUCT_DESC: 14-inch steel irrigation pipe through levee, 3.0 feet below crown. Slant pump in Corrugated metal pump house on steel structure on bank. Meter pole on slope. Siphon breaker on landward shoulder. Discharges into 36-inch concrete standpipe at landward toe. (App. No. 2425 - Hiatt). O&M Manual Sac 128, March 1960. FS Date: 1/14/2014

WS view: slant pump in CM shed on levee berm. Oil leaks from the pump.

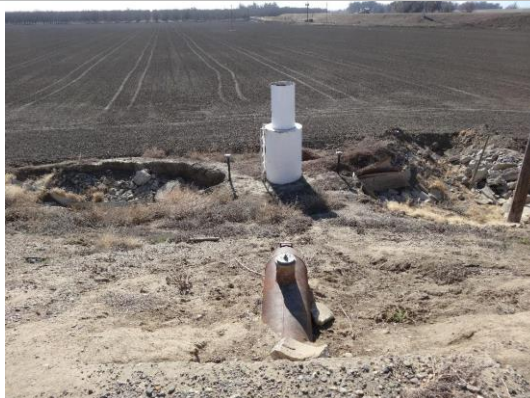
Photo 2 of 2 : UCIP_FA_2016_28505_52516.jpg

LS view: siphon breaker (bottom) on exposed steel pipe on levee slope and steel standpipe (top) on levee toe.

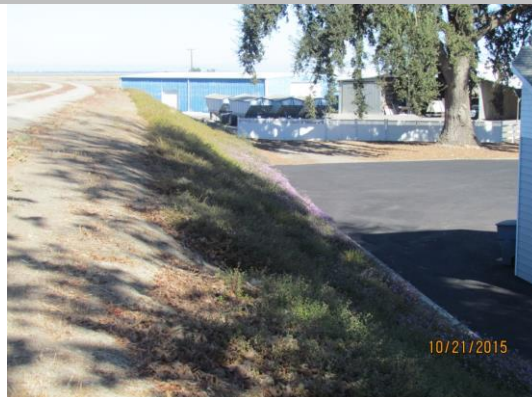
Photo 2 of 2 : FA_2016_RD1500_189_37_20160913_00031.jpg

LM Start	19.01	Rating **	M	Issue No.	37 (cont)	
LM End	19.01	Issue Type +	En	Location *	LS	
Category	Earthen Levee			GPS Latitude/Longitude		
				Start		End
Item	Vegetation			38.901965 °		38.901965 °
				-121.790993 °		-121.790993 °
DWR ID	DWR_RD1500_01_s_2012_37					
Comment Code						
V6 : Landscaping						
Inspector Comment						
Concrete retaining wall along toe of landside levee. Permit #10065

View of the groundcover on the landward side of the levee looking upstream. Fall 2015.

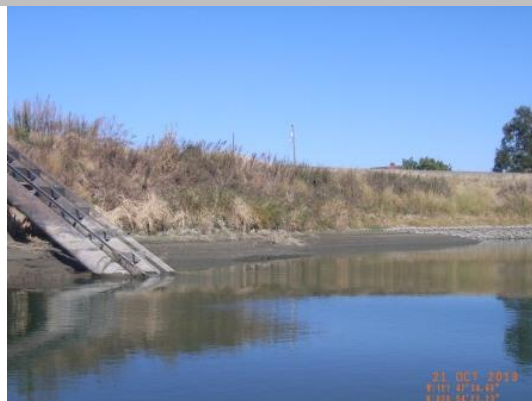
Photo 1 of 1 : FA_2016_RD1500_189_5_20160913_00005.jpg

LM Start	19.16	Rating **	A/W	Issue No.	5
LM End	19.47	Issue Type +	Ma	Location *	WS
Category	Supplemental			GPS Latitude/Longitude	
				Start	End
Item	2015 USACE Erosion Survey, DRAFT			38.904041 °	38.906697 °
				-121.790298 °	-121.792796 °
DWR ID	DWR_RD1500_01_s_2016_5				
Comment Code					
Inspector Comment					
1997 - Cobbles eroded off the clay materials; not much evidence of erosion on the toe; cobble loss on the toe. 2011 - Some minor new erosion. 2015: No observed changes. [2015 Site ID: SAC_104-5_L]

USACE 2013 Photo #1

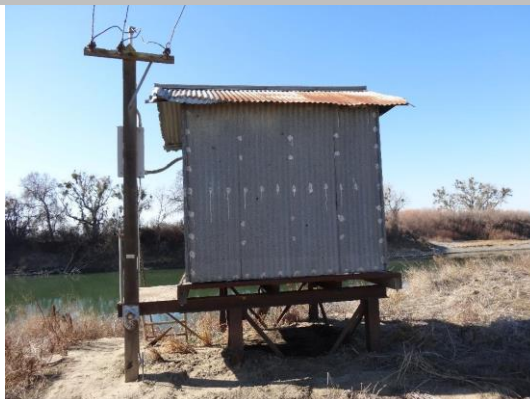
Photo 1 of 2 : UCIP_FA_2016_28506_52523.jpg

LM Start	19.23	Rating **	M	Issue No.	2575
LM End	19.23	Issue Type +	En	Location *	LS
Category	Supplemental			GPS Latitude/Longitude	
				Start	End
Item	DWR UCIP Field Study			38.905029 °	38.905029 °
				-121.790076 °	-121.790076 °
DWR ID					
Comment Code					
Inspector Comment					
FS_ID:28506 DS_ID:20087 EP_NO: 550 Repair Type: Non-Urgent Crossing Status: Found UCIP Comments: Surface erosion on landside slope.Oil leaks from the pump. FIELD_STRUCT_DESC: 14-inch steel irrigation pipe through levee, 4.8 feet below crown. Slant pump and gate valve in CM pump house on steel structure on berm. Water meter installed on pipe on the waterward slope. Concrete distribution box on landward side. (App. No. 550 - Hiatt) O&M Manual Sac 128, March 1960. New permit no. 17648GM- Van Ruiten Bros- June 24, 2003. FS Date: 1/14/2014

WS view: slant pump in CM shed on levee berm. Oil leaks from the pump.

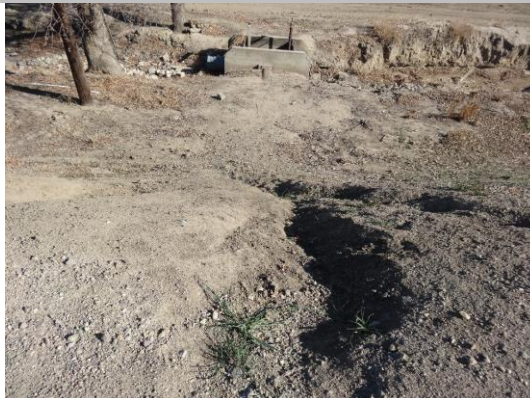
Photo 2 of 2 : UCIP_FA_2016_28506_52522.jpg

LS view: surface erosion on landside levee slope.

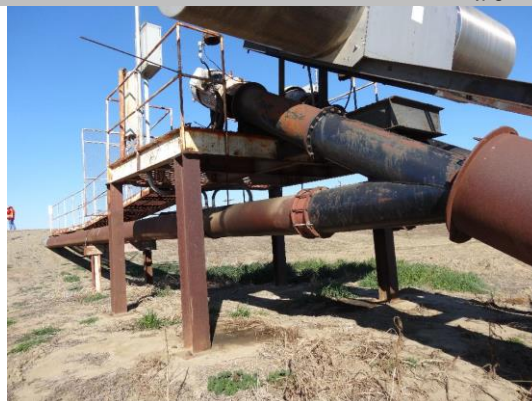
Photo 1 of 2 : UCIP_FA_2016_28524_52551.jpg

Comment Code					
Inspector Comment					
FS_ID:28524 DS_ID:20004 EP_NO: 15681 Repair Type: Non-Urgent Crossing Status: Found UCIP Comments: Obstructed siphon breakers on landside.Two 3-inch conduit through the levee.Service box on pump platform.Pumping plant was working during the field visit. FIELD_STRUCT_DESC: 1 of 2: Two slant pumps supported by steel piling on the riverbank. 16 and 18-inches steel pipelines, asphalt coated inside and out and wrapped with asphalt saturated felt through the levee section to a concrete discharge box located landward of the landward levee toe. Pipes 1.5 feet below the crown. Siphon breakers in steel pipe risers on levee slope. (App. No. 15681) FS Date: 1/14/2014

WS view: pipe, walkway, slant pump, and steel platform on levee berm.

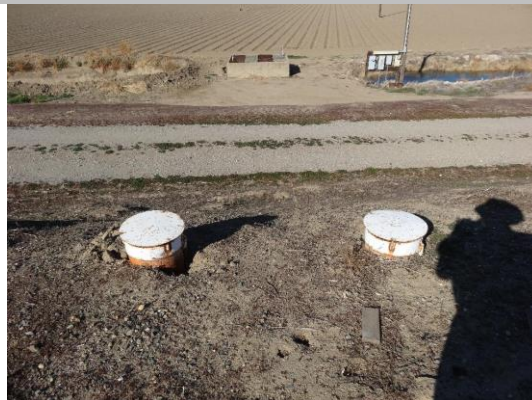
Photo 2 of 2 : UCIP_FA_2016_28524_52550.jpg

LS view: siphon breakers in steel pipe risers (bottom) on levee slope and concrete distribution (top) box on levee toe.

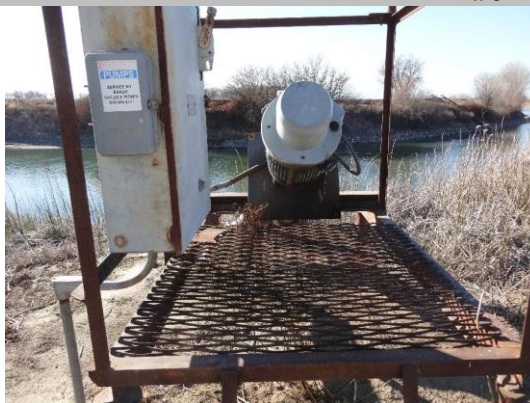
Photo 1 of 2 : UCIP_FA_2016_28527_52568.jpg

LM Start	21.26	Rating **	M	Issue No.	2551
LM End	21.26	Issue Type +	En	Location *	LS
Category	Supplemental			GPS Latitude/Longitude	
				Start	End
Item	DWR UCIP Field Study			38.914659 °	38.914659 °
				-121.803609 °	-121.803609 °
DWR ID					
Comment Code					
Inspector Comment					
FS_ID:28527 DS_ID:20070 EP_NO: 11959A Repair Type: Non-Urgent Crossing Status: Found UCIP Comments: Siphon breaker (obstructed) in CMP on landside slope.Power pole on landside toe. FIELD_STRUCT_DESC: 10-inch steel pipe through levee, 3.0 feet below crown with slant pump on steel platform. Siphon breaker (obstructed) in CMP on landside slope. A 6 foot by 6 foot concrete distribution box on landward side. (App. No. 11959A - Van Ruiten) O&M Manual Sac 128, March 1960. FS Date: 1/14/2014

WS view: slant pump on steel platform on levee berm.

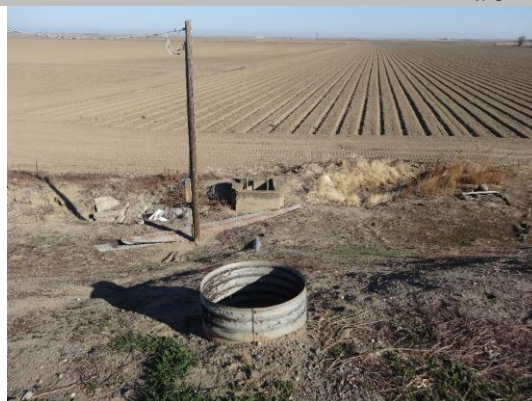
Photo 2 of 2 : UCIP_FA_2016_28527_52567.jpg

LM Start	21.26	Rating **	M	Issue No.	2551 (cont)	
LM End	21.26	Issue Type +	En	Location *	LS	
Category	Supplemental			GPS Latitude/Longitude		
				Start		End
Item	DWR UCIP Field Study			38.914659 °		38.914659 °
				-121.803609 °		-121.803609 °
DWR ID						
Comment Code						
Inspector Comment						
FS_ID:28527 DS_ID:20070 EP_NO: 11959A Repair Type: Non-Urgent Crossing Status: Found UCIP Comments: Siphon breaker (obstructed) in CMP on landside slope.Power pole on landside toe. FIELD_STRUCT_DESC: 10-inch steel pipe through levee, 3.0 feet below crown with slant pump on steel platform. Siphon breaker (obstructed) in CMP on landside slope. A 6 foot by 6 foot concrete distribution box on landward side. (App. No. 11959A - Van Ruiten) O&M Manual Sac 128, March 1960. FS Date: 1/14/2014

LS view: siphon breaker in CMP riser on levee slope (bottom) and concrete distribution box (top) on levee toe.

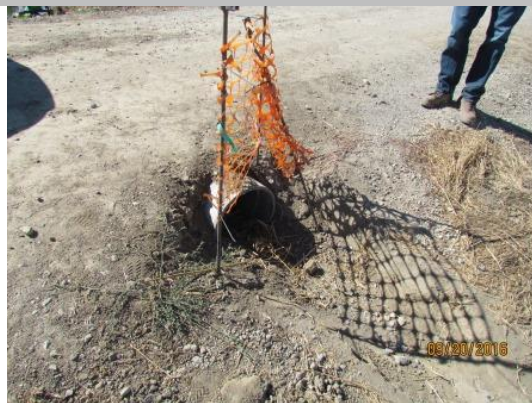
Photo 1 of 3 : FA_2016_RD1500_189_98_20160926_00237.jpg

LM Start	21.58	Rating **	U	Issue No.	98
LM End	21.58	Issue Type +	En	Location *	CR
Category	Earthen Levee			GPS Latitude/Longitude	
				Start	End
Item	Encroachments			38.916180 °	38.916180 °
				-121.808850 °	-121.808850 °
DWR ID	DWR_RD1500_01_f_2016_98				
Comment Code					
PI : Pipe					
Inspector Comment					
Pipe open on both ends. No permit. Rebar and pipe on slope.

View of pipe on landside slope. Open on both ends. Less than a foot below the crown. Intended for drain hose go through the levee. Drain hose located nearby. Fall 2016.

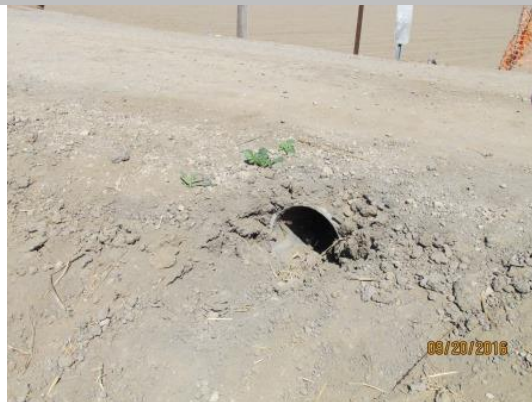
Photo 2 of 3 : FA_2016_RD1500_189_98_20160926_00239.jpg

View of pipe on waterward side. Fall 2016.

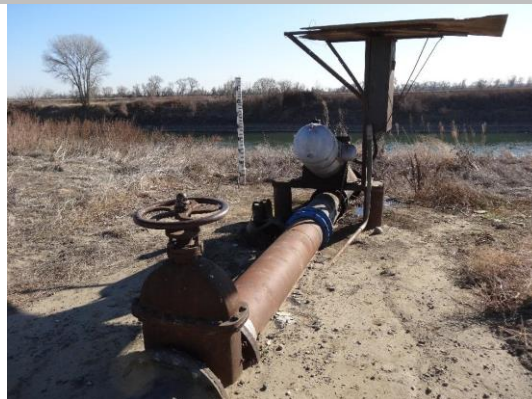
Photo 1 of 2 : UCIP_FA_2016_28528_52576.jpg

Comment Code					
Inspector Comment					
FS_ID:28528					
DS_ID:20071					
EP_NO: 10063					
Repair Type: Non-Urgent					
Crossing Status: Found					
UCIP Comments: Water leaks near pump. Obstructed siphon breaker in CMP on landside.Plant was working during field visit.					
FIELD_STRUCT_DESC: 16-inch steel irrigation pipe through levee 6.3 feet below crown. 1-1/2-inch conduit through levee, 6.5 feet below crown. Slant pump and gate valve on berm. Siphon breaker in 24-inch corrugated metal riser on landward slope. CMP standpipe on landside toe. Power pole and one anchor at landward toe. (ABO. No. 10063, 11/1974 - Nelson) O&M Manual Sac 128, March 1960.					
FS Date: 1/14/2014

WS view: slant pump on steel platform on levee berm. Exposed steel pipe with gate valve also on levee berm.

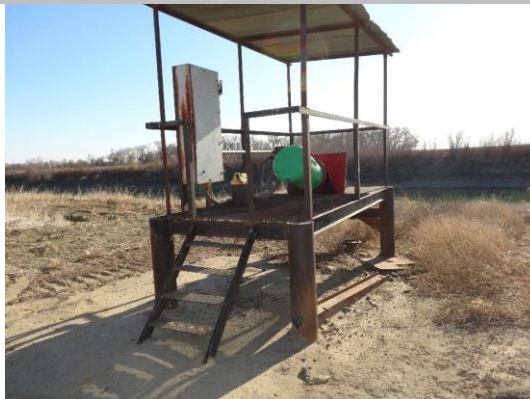
Photo 1 of 2 : UCIP_FA_2016_50192_52587.jpg

FS_ID:50192
DS_ID:20083
EP_NO: 2895
Repair Type: Non-Urgent
Crossing Status: Found
UCIP Comments: 09/20/2016 Inspection 09/20/2016-1100 for Permit No: 2895-1 performed by Oleg Yakimov and George Wylie of FPIIB. Photos show condition of pipe before it was removed and replaced. (K. Fazel - UCIP)01/14/2014:Obstructed siphon breaker.Plant was working during field visit. (P. Amatya - DWR)
FIELD_STRUCT_DESC: *REMOVED* 12-inch steel irrigation pipe through levee, 5.8 feet below crown. 1.5-inch conduit through levee, 4 feet below crown. Pump and gate valve on bank. Switch panel on berm. Siphon breaker in 24-inch CM riser on landward slope. Discharges into 36-inch CM standpipe on landward side. Service pole at landward toe. Pumping Plant No. 3. (App. No. 10851, 2895 - George Van Ruiten). Pipe removed and replaced under Secondary Permit No. 2895-1, 2016 - Van Ruiten Bros (DSID 25472).
FS Date: 9/26/2016

WS view: slant pump on steel platform on levee berm.

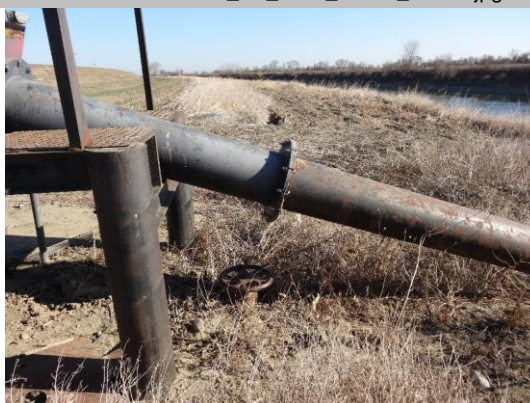
Photo 2 of 2 : UCIP_FA_2016_50192_52586.jpg

WS view: slant pipe and gate valve at the end of levee berm.

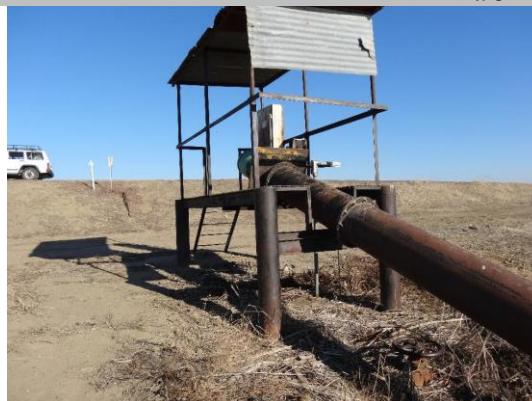
Photo 1 of 2 : UCIP_FA_2016_28583_52627.jpg

Comment Code					
Inspector Comment					
FS_ID:28583 DS_ID:19995 EP_NO: 10851 Repair Type: Non-Urgent Crossing Status: Found UCIP Comments: Exposed conduit on both slopes of the levee. Plant was working during field visit. Water was leaking from pipe joint near pump.Obstructed siphon breaker in CMP. FIELD_STRUCT_DESC: 14-inch steel irrigation pipe through levee, 6.2 feet below crown. Pump and gate valve on steel platform. Switch panel on berm. Siphon breaker in 24-inch CM riser on landward shoulder. Discharges into 36-inch CM standpipe at landward toe. 2-inch conduit through levee, 5.0 feet below crown. Service pole at landward toe. Pumping plant No. 2. (App. No. 10851, 2895 - Van Ruiten) FS Date: 1/14/2014

WS view: slant pump on steel platform on levee berm.

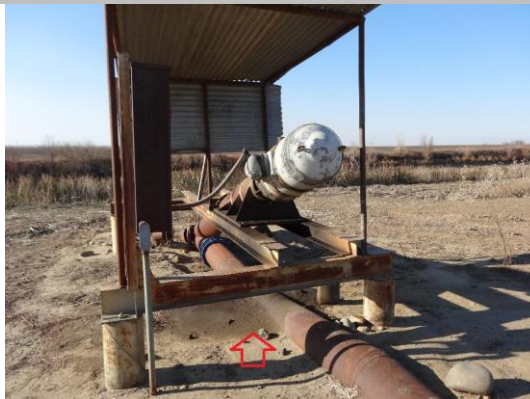
Photo 1 of 2 : UCIP_FA_2016_28586_52642.jpg

FS_ID:28586
DS_ID:20072
EP_NO: 2895
Repair Type: Non-Urgent
Crossing Status: Found
UCIP Comments: Most of the pipe exposed on levee slopes. Leaky pump. Obstructed siphon breaker. Not found- Concrete headwall at landward toe.
FIELD_STRUCT_DESC: 14-inch steel irrigation pipe through levee, 6.5 feet below crown. 1-1/2 inch conduit through levee, 4.0 feet below crown. Slant pump and control panel on steel structure on berm. Siphon breaker in 24-inch corrugated metal riser on landward shoulder. 36-inch CM standpipe at landward toe. Service pole at landward toe. Pumping-Plant No. 1. (App. No. 2895 - Van Ruiten) O&M Manual Sac 128, March 1960.
FS Date: 1/14/2014

WS view: slant pump on steel platform on levee berm. Oil leaks from the pump (marked). Exposed pipe on the berm.

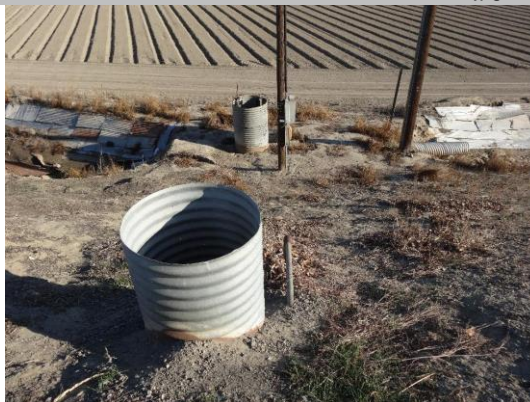
Photo 2 of 2 : UCIP_FA_2016_28586_52641.jpg

LS view: siphon breaker in CMP riser on levee slope (bottom) and CM standpipe (top) on levee toe.

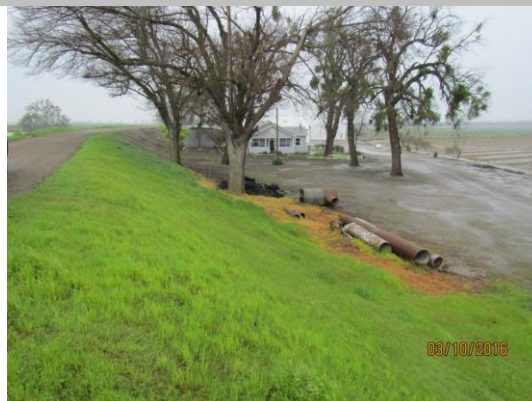
Photo 1 of 1 : FA_2016_RD1500_189_176_20160913_00078.jpg

LM Start	23.71	Rating **	M	Issue No.	176
LM End	23.71	Issue Type +	En	Location *	LS
Category	Earthen Levee			GPS Latitude/Longitude	
				Start	End
Item	Encroachments			38.931045 °	38.931045 °
				-121.834795 °	-121.834795 °
DWR ID	DWR_RD1500_01_s_2016_176				
Comment Code					
DE : Debris					
Inspector Comment

View of the pipes along the toe of the landward side of the levee looking upstream. Spring 2016.

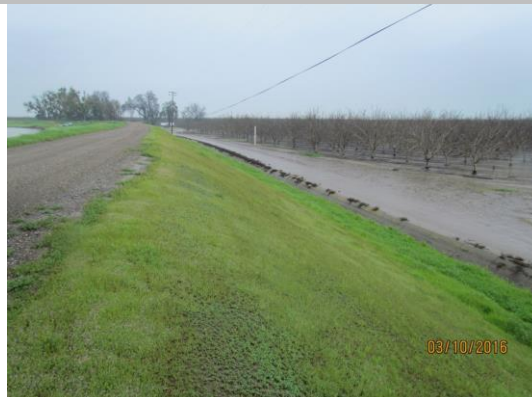
Photo 1 of 1 : FA_2016_RD1500_189_979_20160913_00084.jpg

LM Start	24.17	Rating **	M	Issue No.	979
LM End	24.31	Issue Type +	En	Location *	LS
Category	Earthen Levee			GPS Latitude/Longitude	
				Start	End
Item	Encroachments			38.936419 °	38.938426 °
				-121.830220 °	-121.829365 °
DWR ID	DWR_RD1500_01_s_2012_979				
Comment Code					
DT : Ditch					
Inspector Comment					
Concrete lined ditch located at the levee toe on the landward side of the levee.

View of the ditch on the landward side of the levee looking upstream.
Spring 2016.

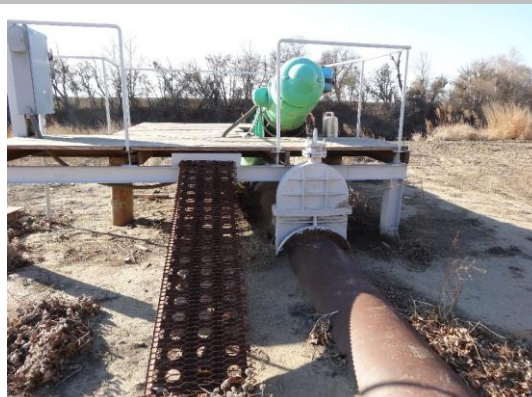
Photo 1 of 2 : UCIP_FA_2016_28603_52667.jpg

LM Start	24.31	Rating **	M	Issue No.	2560
LM End	24.31	Issue Type +	En	Location *	LS
Category	Supplemental			GPS Latitude/Longitude	
				Start	End
Item	DWR UCIP Field Study			38.938431 °	38.938431 °
				-121.829350 °	-121.829350 °
DWR ID					
Comment Code					
Inspector Comment					
FS_ID:28603					
DS_ID:24757					
EP_NO: 10057					
Repair Type: Non-Urgent					
Crossing Status: Found					
UCIP Comments: Plant was working during field visit.Leaky pipe near pump.					
FIELD_STRUCT_DESC: 24-inch steel irrigation pipe 6.5 ft below crown; walkway to slant pump. Gate valve on berm. 24-in CM riser with siphon breaker and 4 ft x 7 ft concrete distribution box on landside toe.					
(Source: Leve Log 1/1/1990 and Fieild visit 1/14/2014)					
FS Date: 1/14/2014

WS view: slant pump on steel platform at levee berm. Walkway, exposed pipe, and gate valve on the berm.

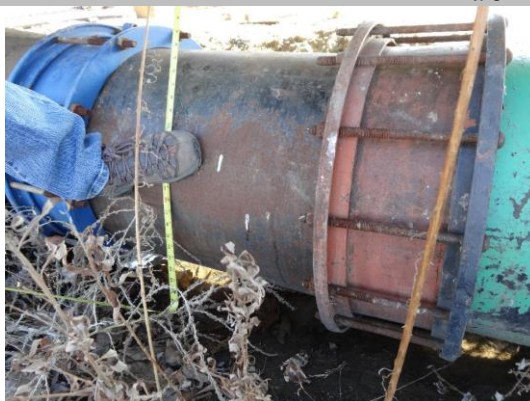
Photo 2 of 2 : UCIP_FA_2016_28603_52666.jpg

WS view: leaky pipe near pump platform. Pipe leaks from the joint.

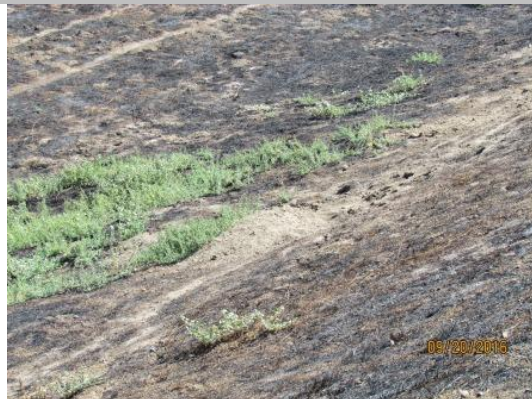
Photo 1 of 3 : FA_2016_RD1500_189_102_20160926_00245.jpg

A number of burrows was observed at this site on landward slope. Fall 2016.

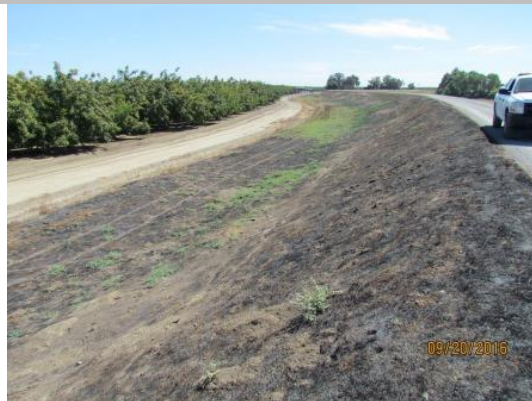
Photo 2 of 3 : FA_2016_RD1500_189_102_20160926_00251.jpg

Landside slope perspective view. Fall 2016.

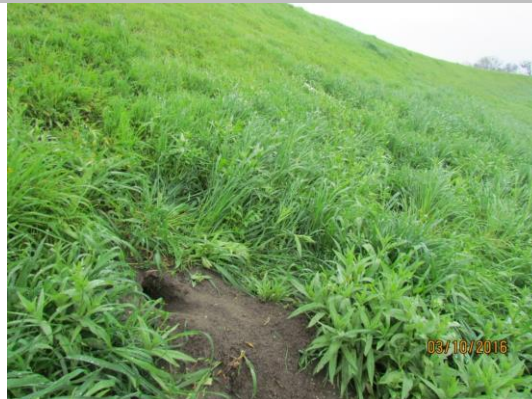
Photo 3 of 3 : FA_2016_RD1500_189_102_20160913_00054.jpg

View of rodent hole on the landward side of the levee looking upstream. Spring 2016.

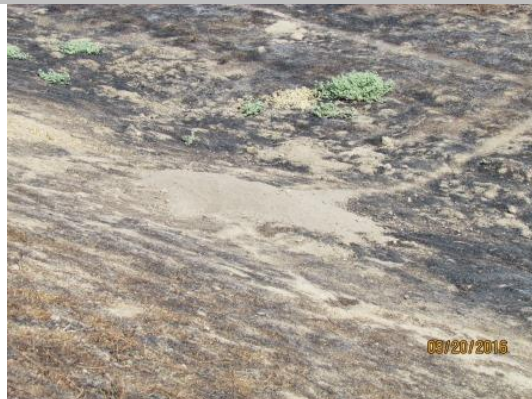
Photo 1 of 2 : FA_2016_RD1500_189_101_20160926_00246.jpg

LM Start	24.82	Rating **	U	Issue No.	101
LM End	24.82	Issue Type +	Ma	Location *	LS
Category	Earthen Levee			GPS Latitude/Longitude	
				Start	End
Item	Animal Control			38.943510 °	38.943510 °
				-121.835431 °	-121.835431 °
DWR ID	DWR_RD1500_01_f_2016_101				
Comment Code					
A1 : Exterminate rodents and backfill and compact or grout burrows.					
Inspector Comment

Number of burrows with significant amount of soil taken out was observed on LS slope of the levee. Fall 2016.

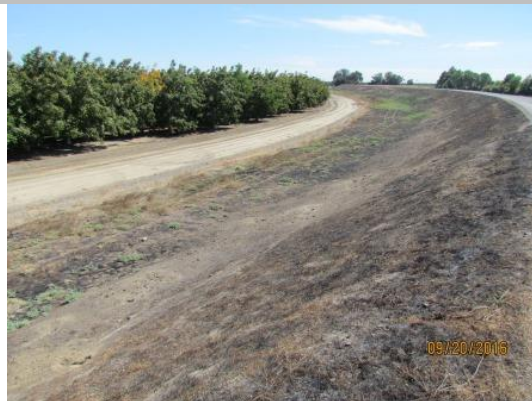
Photo 2 of 2 : FA_2016_RD1500_189_101_20160926_00248.jpg

Landside slope perspective view. Fall 2016.

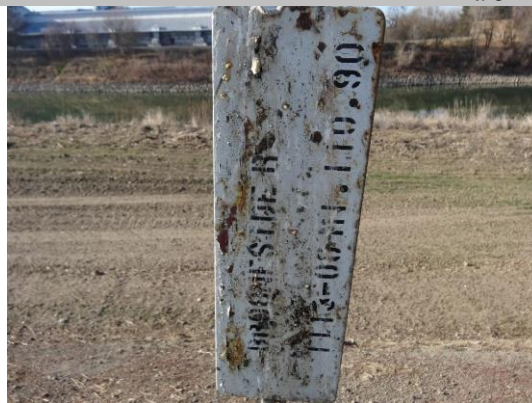
Photo 1 of 2 : UCIP_FA_2016_41728_52673.jpg

LM Start	25.49	Rating **	M	Issue No.	2589
LM End	25.49	Issue Type +	En	Location *	LS
Category	Supplemental			GPS Latitude/Longitude	
				Start	End
Item	DWR UCIP Field Study			38.952803 °	38.952803 °
				-121.837618 °	-121.837618 °
DWR ID					
Comment Code					
Inspector Comment					
FS_ID:41728 DS_ID:20074 EP_NO: 8765 Repair Type: Non-Urgent Crossing Status: Found UCIP Comments: Burried Concrete headwall on landside toe. Should verify pipe has been properly abandoned.Utility tag plate on waterside shoulder.No pipe found. FIELD_STRUCT_DESC: *ABANDONED* 4 foot by 4 foot reinforced concrete pipe through levee, 10 feet below the crown. App. No. 8765 has been approved to sleeve a 20-inch pipe through existing pipe from a new pumping facility. (App. No. 8765 & 9175 - Lewis) O&M Manual Sac 128, March 1960. FS Date: 1/15/2014

WS view: utility tag plate on waterside shoulder. No pipe found.

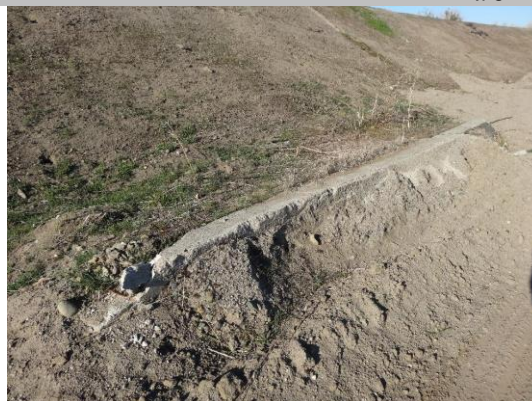
Photo 2 of 2 : UCIP_FA_2016_41728_52672.jpg

LS view: concrete headwall on landside toe. No pipe found.

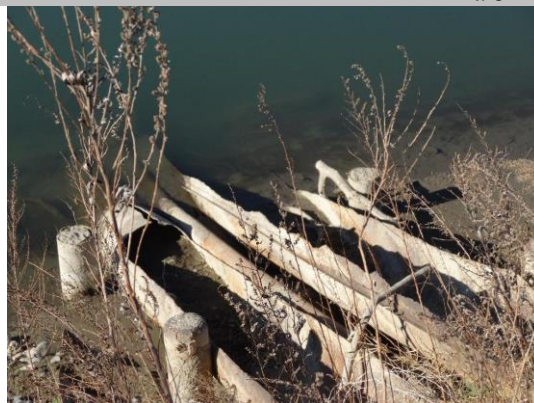
Photo 1 of 2 : UCIP_FA_2016_28629_52709.jpg

LM Start	26.52	Rating **	M	Issue No.	2564
LM End	26.52	Issue Type +	En	Location *	LS
Category	Supplemental			GPS Latitude/Longitude	
				Start	End
Item	DWR UCIP Field Study			38.964915 °	38.964915 °
				-121.833675 °	-121.833675 °
DWR ID					
Comment Code					
Inspector Comment					
FS_ID:28629					
DS_ID:20014					
EP_NO: 10057					
Repair Type: Non-Urgent					
Crossing Status: Found					
UCIP Comments: May need proper abandonment.					
FIELD_STRUCT_DESC: Abandoned 24-inch pipe through levee, 7.1					
feet below the crown, slant pump on WS. O&M Manual Sac 128, March					
1960. (ABO No. 10057)					
FS Date: 1/15/2014

WS view: abandoned 24" and 30" steel pipe on river bank.

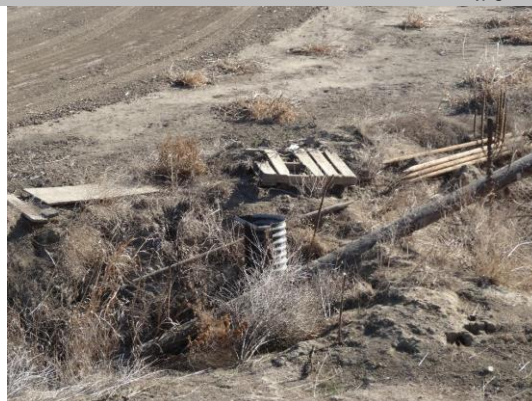
Photo 2 of 2 : UCIP_FA_2016_28629_52708.jpg

LM Start	26.52	Rating **	M	Issue No.	2564 (cont)
LM End	26.52	Issue Type +	En	Location *	LS
Category	Supplemental			GPS Latitude/Longitude	
				Start	End
Item	DWR UCIP Field Study			38.964915 °	38.964915 °
				-121.833675 °	-121.833675 °
DWR ID					
Comment Code					
Inspector Comment					
FS_ID:28629 DS_ID:20014 EP_NO: 10057 Repair Type: Non-Urgent Crossing Status: Found UCIP Comments: May need proper abandonment. FIELD_STRUCT_DESC: Abandoned 24-inch pipe through levee, 7.1 feet below the crown, slant pump on WS. O&M Manual Sac 128, March 1960. (ABO No. 10057) FS Date: 1/15/2014

LS view: abandoned CMP risers on levee toe.

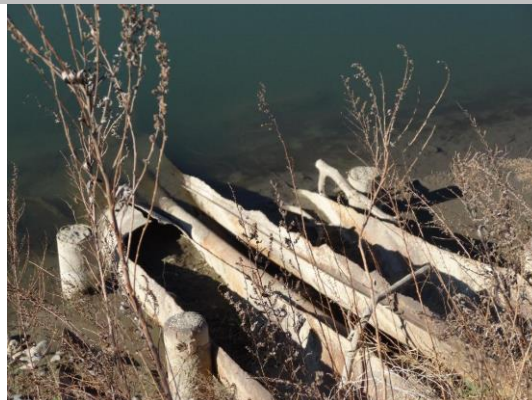
Photo 1 of 2 : UCIP_FA_2016_28628_52705.jpg

LM Start	26.52	Rating **	M	Issue No.	2563
LM End	26.52	Issue Type +	En	Location *	LS
Category	Supplemental			GPS Latitude/Longitude	
				Start	End
Item	DWR UCIP Field Study			38.964931 °	38.964931 °
				-121.833682 °	-121.833682 °
DWR ID					
Comment Code					
Inspector Comment					
FS_ID:28628 DS_ID:20013 EP_NO: 10057 Repair Type: Non-Urgent Crossing Status: Found UCIP Comments: May need proper abandonment. FIELD_STRUCT_DESC: Abandoned 30-inch pipe through levee, 7.1 feet below the crown, pump on WS. O&M Manual Sac 128, March 1960. (ABO No. 10057) FS Date: 1/15/2014

WS view: abandoned 24" and 30" steel pipe on river bank.

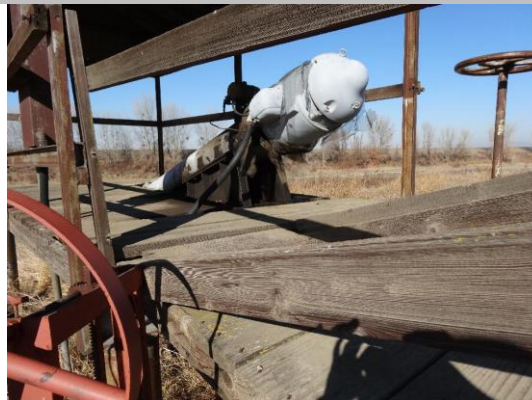
Photo 1 of 2 : UCIP_FA_2016_28631_52720.jpg

LM Start	26.74	Rating **	M	Issue No.	2565
LM End	26.74	Issue Type +	En	Location *	LS
Category	Supplemental			GPS Latitude/Longitude	
				Start	End
Item	DWR UCIP Field Study			38.968093 °	38.968093 °
				-121.833708 °	-121.833708 °
DWR ID					
Comment Code					
Inspector Comment					
FS_ID:28631 DS_ID:20015 EP_NO: 10052 Repair Type: Non-Urgent Crossing Status: Found UCIP Comments: Obstructed siphon breaker. Leaky pump. FIELD_STRUCT_DESC: 18-inch steel irrigation pipe through levee, 7.1 feet below crown. 2-inch conduit through levee, 5.5 feet below crown. Wood walkway to slant pump and gate valve on wooden pump platform mounted on steel pile structure on berm. Siphon breaker in 24-inch CM riser on landward slope. Meter pole at landward toe. (ABO No. 10052 - Lamb) (RM 112.29) O&M Manual Sac 128, March 1960. FS Date: 1/15/2014

WS view: slant pump and gate valves on wooden platform at levee berm. Wooden walkway to the pump.

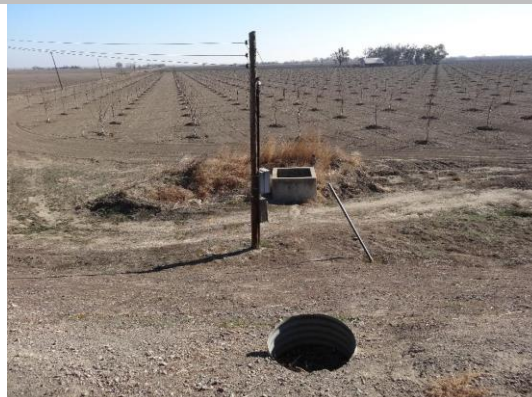
Photo 2 of 2 : UCIP_FA_2016_28631_52719.jpg

LM Start	26.74	Rating **	M	Issue No.	2565 (cont)
LM End	26.74	Issue Type +	En	Location *	LS
Category	Supplemental			GPS Latitude/Longitude	
				Start	End
Item	DWR UCIP Field Study			38.968093 °	38.968093 °
				-121.833708 °	-121.833708 °
DWR ID					
Comment Code					
Inspector Comment					
FS_ID:28631 DS_ID:20015 EP_NO: 10052 Repair Type: Non-Urgent Crossing Status: Found UCIP Comments: Obstructed siphon breaker. Leaky pump. FIELD_STRUCT_DESC: 18-inch steel irrigation pipe through levee, 7.1 feet below crown. 2-inch conduit through levee, 5.5 feet below crown. Wood walkway to slant pump and gate valve on wooden pump platform mounted on steel pile structure on berm. Siphon breaker in 24-inch CM riser on landward slope. Meter pole at landward toe. (ABO No. 10052 - Lamb) (RM 112.29) O&M Manual Sac 128, March 1960. FS Date: 1/15/2014

LS view: siphon breaker in CMP riser on levee slope (bottom) and concrete distribution box on levee toe.

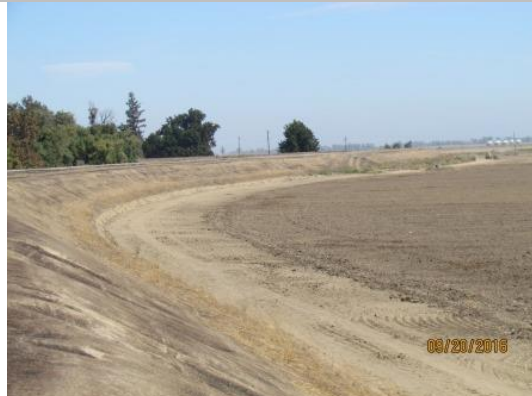
Photo 1 of 1 : FA_2016_RD1500_189_105_20160926_00254.jpg

LM Start	26.99	Rating **	M	Issue No.	105
LM End	27.28	Issue Type +	En	Location *	LS
Category	Earthen Levee			GPS Latitude/Longitude	
				Start	End
Item	Encroachments			38.970964 °	38.972455 °
				-121.830928 °	-121.826024 °
DWR ID	DWR_RD1500_01_f_2016_105				
Comment Code					
AT : Agricultural tilling					
Inspector Comment					
Cut into toe at landside due to agricultural activity.

Levee toe on landside has been cut due to agricultural activity. Fall 2016.

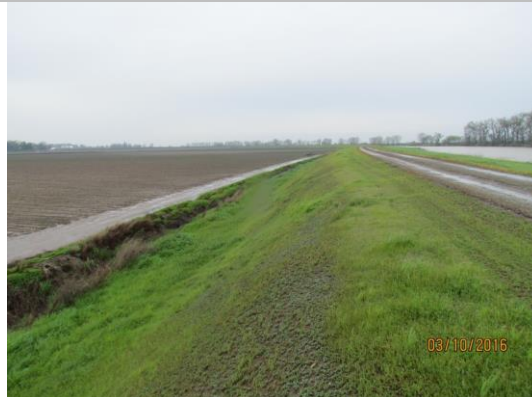
Photo 1 of 1 : FA_2016_RD1500_189_983_20160913_00085.jpg

LM Start	27.31	Rating **	M	Issue No.	983
LM End	27.44	Issue Type +	En	Location *	LS
Category	Earthen Levee			GPS Latitude/Longitude	
				Start	End
Item	Encroachments			38.972552 °	38.972924 °
				-121.825574 °	-121.823198 °
DWR ID	DWR_RD1500_01_s_2015_983				
Comment Code					
DT : Ditch					
Inspector Comment

View of the ditch on the landward side of the levee looking downstream.
Spring 2016.
